## Simple Overhead Repairs with Belzona® 4141

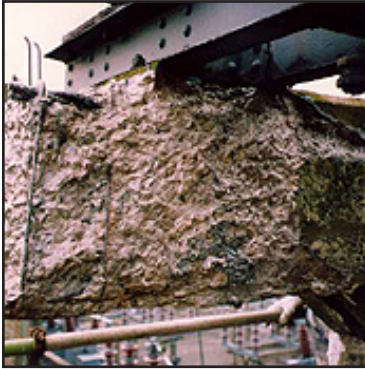
Close up of the badly spalled concrete

Severe spalling of the concrete accelerated by the acidic atmosphere generated by local industries.

Application was carried out using similar techniques to those detailed in Belzona® Know-How leaflet RPA-2. Repairs were finally overcoated with Belzona® 5151 as preventive maintenance on surrounding concrete surfaces.
