## Leaky Cylinder Seats Refurbished with Belzona

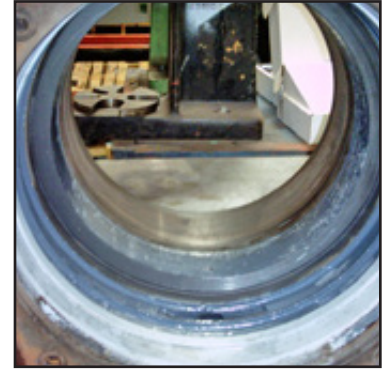
Ready for service
