Belzona Repair of Access Ramp and Steps

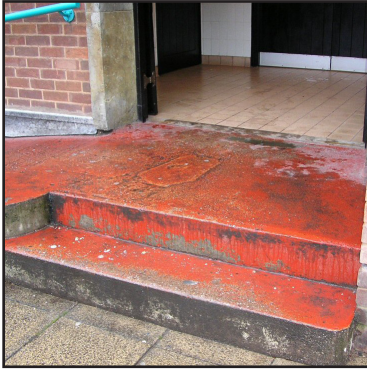
Worn steps were a health and safety hazard

Much foot traffic and heavy weathering caused the steps and disabled access ramp of these public toilets to become damaged and worn. An inspection of the ramps according to the Disability Discrimination Act (DDA) found them to be unsafe and not compliant.

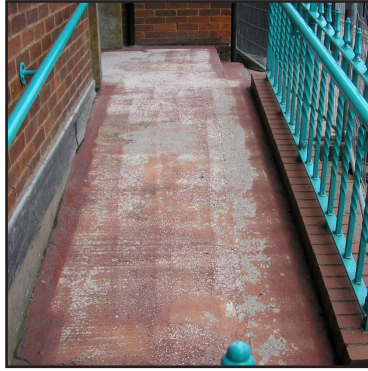
Prepared surface

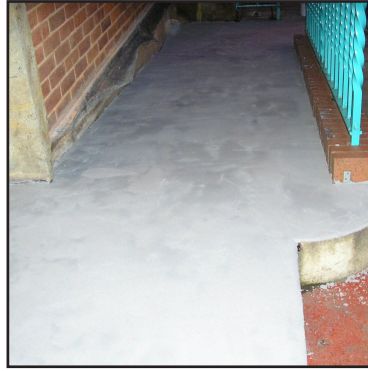
Surface rebuilt with Belzona® 4131

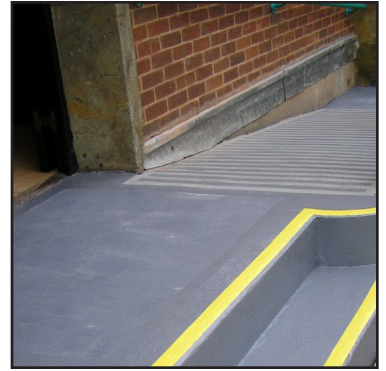
Completed project
