Belzona Flange Face Forming Kit

All the necessary accessories at hand for in-situ flange face repair and protection

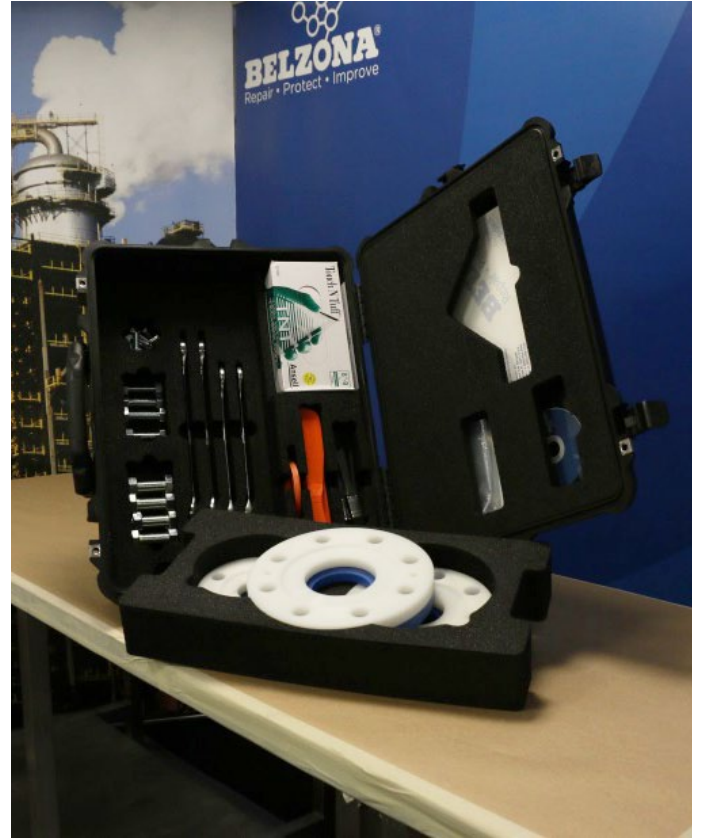
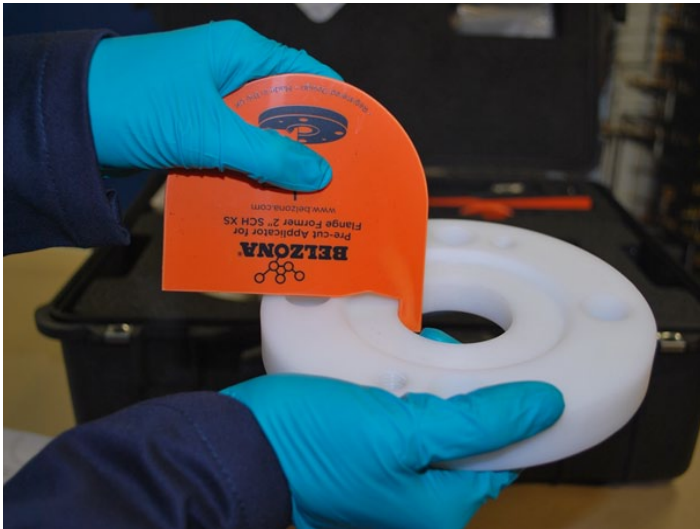
The Belzona Flange Face Forming Kit includes all the equipment* required to effectively complete a Belzona flange face forming repair, eliminating the need for spare flanges of multiple sizes, saving time on sourcing separate flange formers and avoiding hot work. It contains 6 reusable plastic formers to repair the most common flange sizes found in the industry, as well as other necessary application tools for a quick and easy repair.

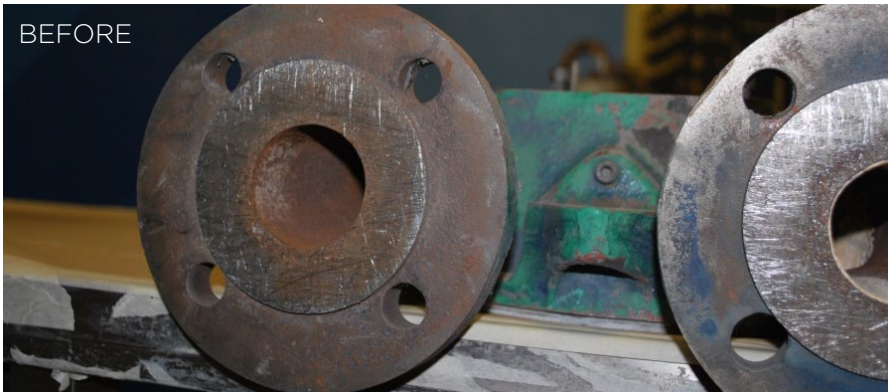
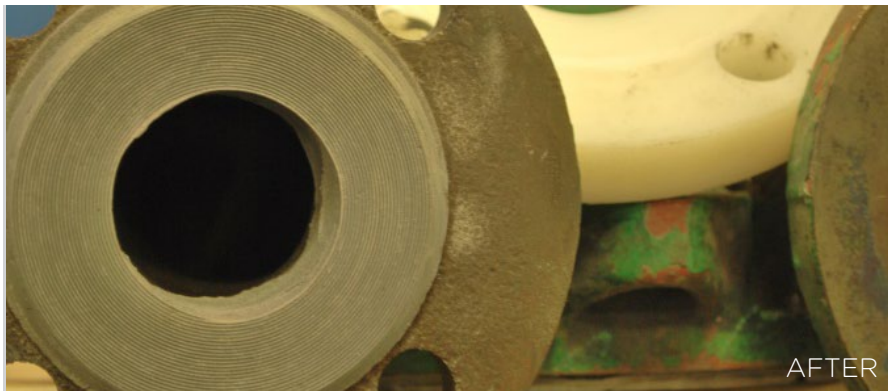
Most common pipe schedules that can be repaired with Belzona Flange Face Forming Kit
